Poly fine

Corrosive water solution

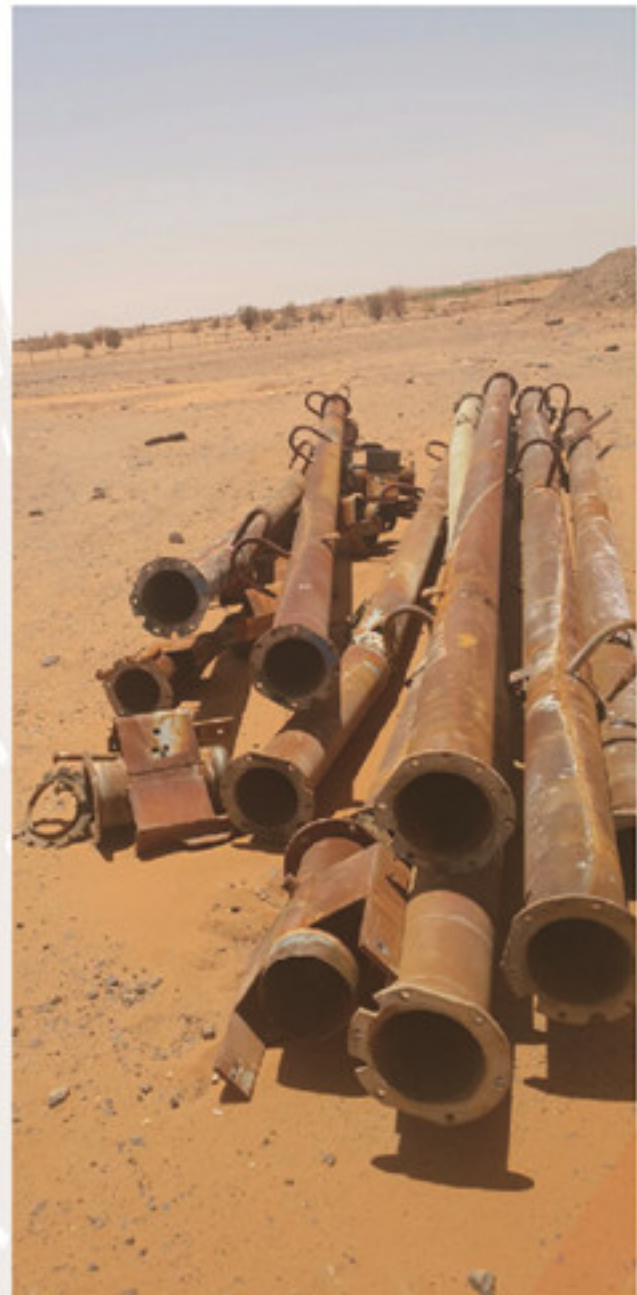
Corrosive pipe caused by bad quality water

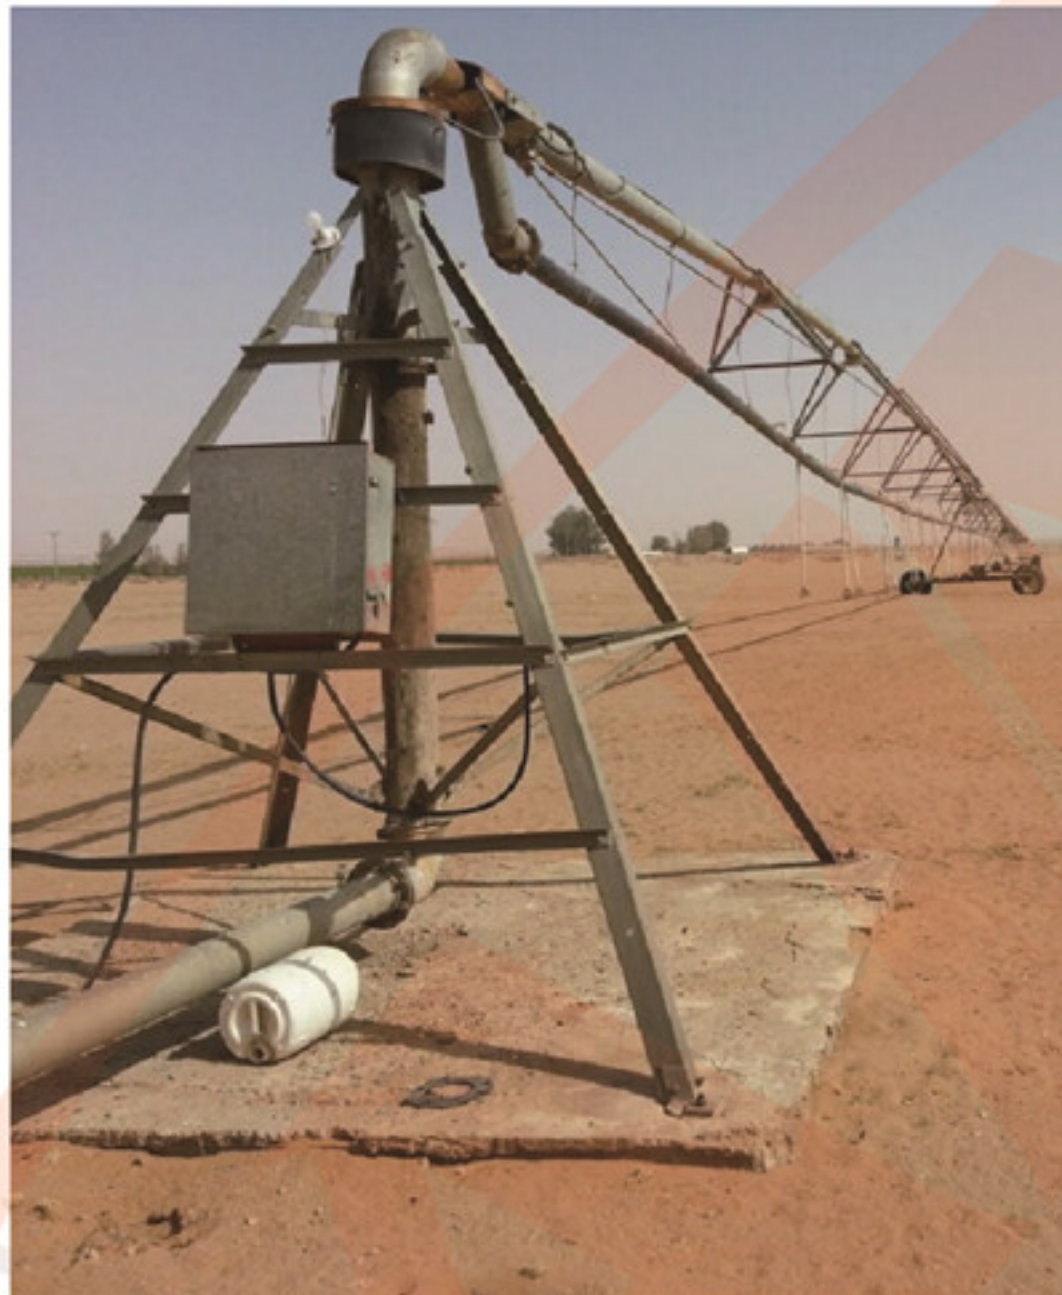
PE pipe under the steel pipe poor water application

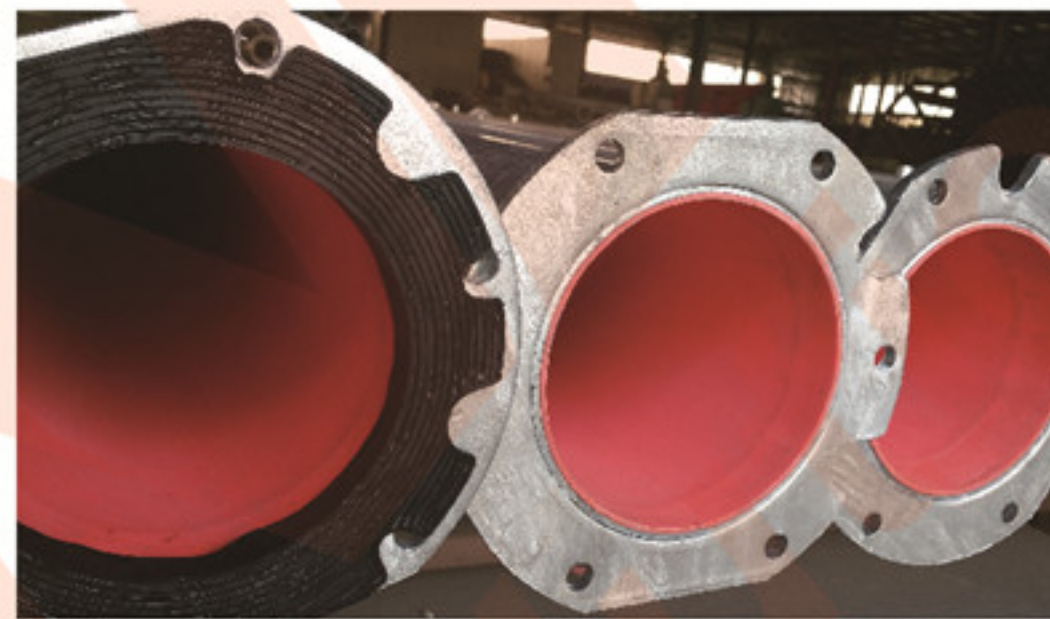
◀ 2.5mm plastic coating inside the galvanized pipe

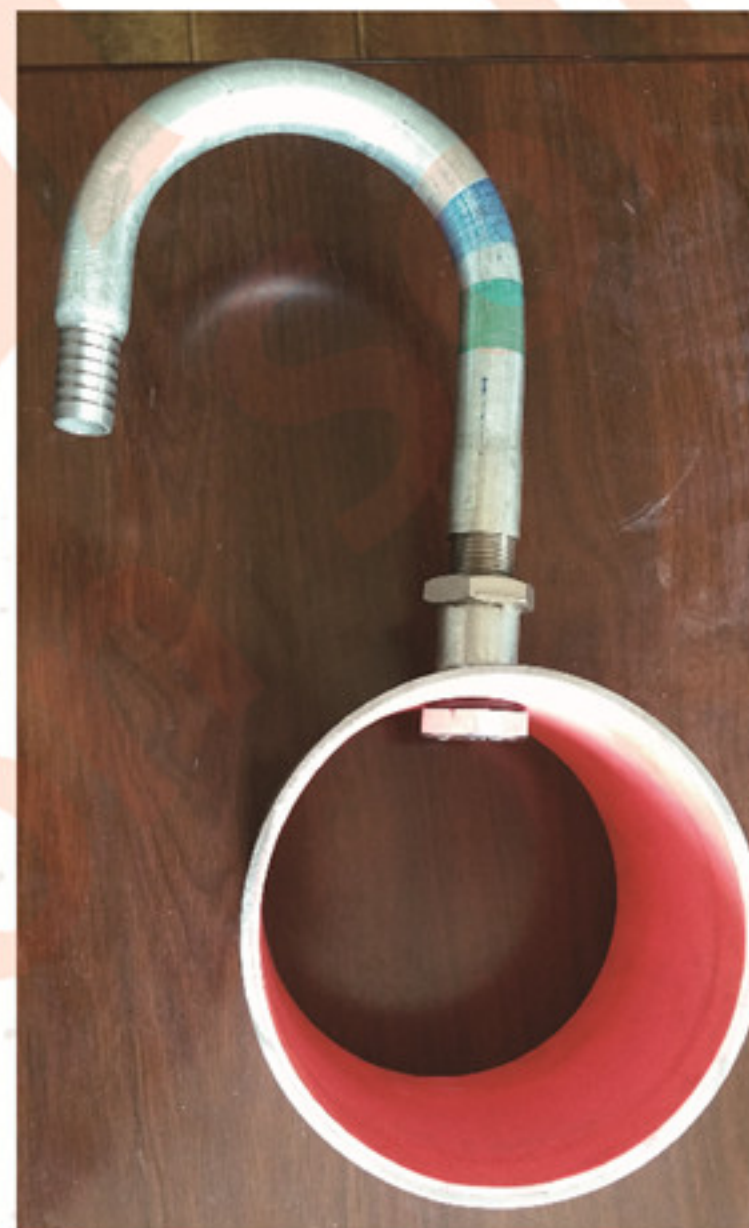
Outlet: ▶ 304 stainless steels

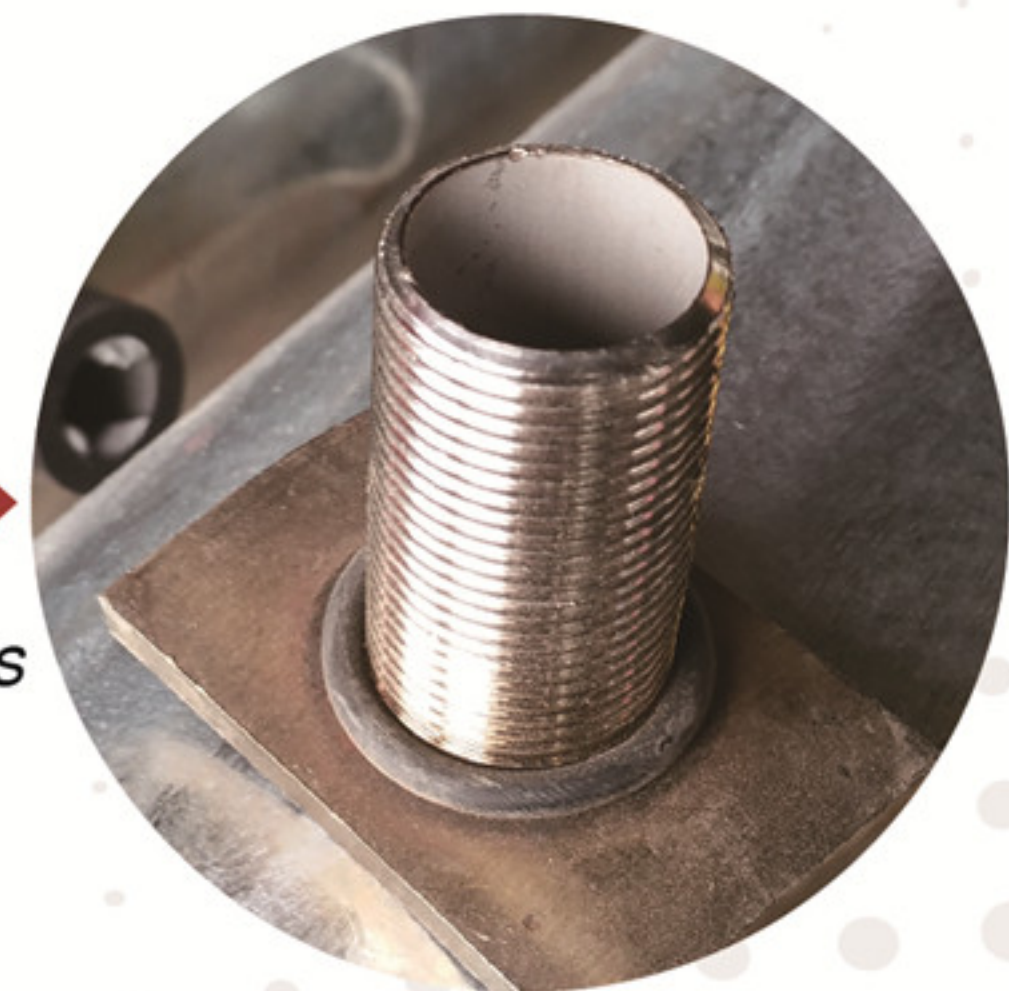
◀ Female-hose barb stainless steel goosenecks are used on the outlet.
